DYNAMIC SCIENCE, INC.
In-Depth Accident Investigation

Contract DTNH22-87-C-47169
Case DSI-93-AB-003

TECHNICAL SUMMARY

CONTRACTOR: Dynamic Science, Inc.
CONTRACT NUMBER: DTNH22-87-C-47169
CASE NUMBER: DSI-93-AB-003

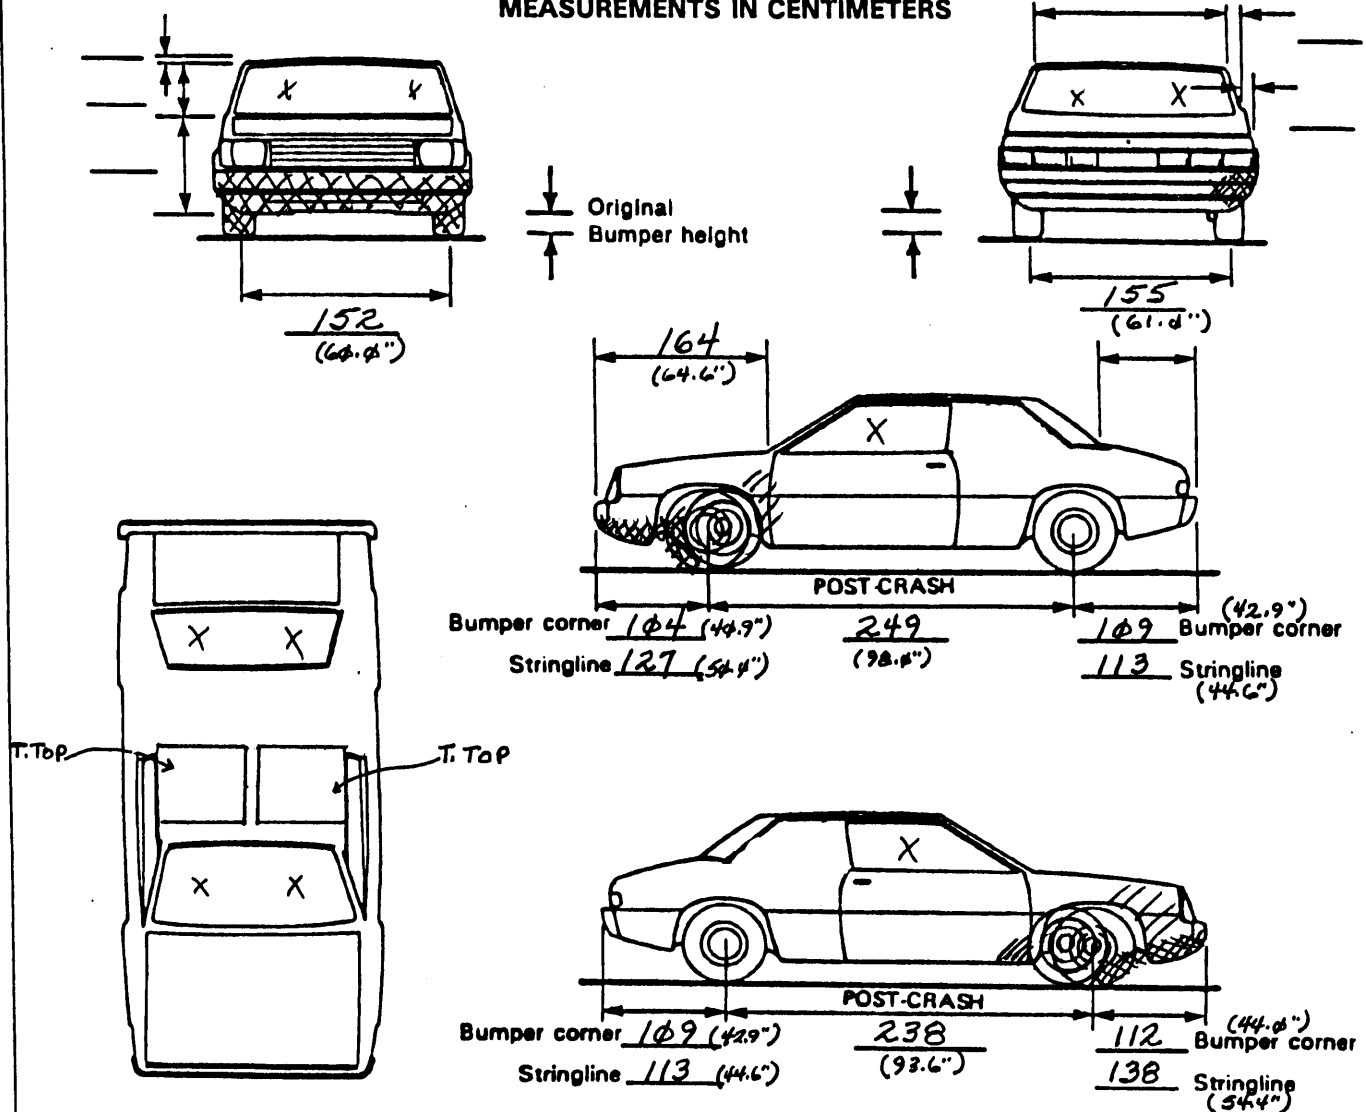
VEHICLE DAMAGE SKETCH

TIRE—WHEEL DAMAGE a. Rotation physically restricted b. Tire deflated RF <u>1</u> <i>FIRE DAMAGE</i> RF <u>1</u> LF <u>1</u> <i>FIRE DAMAGE</i> LF <u>1</u> RR <u>2</u> RR <u>2</u> LR <u>2</u> <i>FIRE DAMAGE</i> LR <u>1</u> (1) Yes (2) No (8) NA (9) Unk.		ORIGINAL SPECIFICATIONS Wheelbase <u>257</u> cm Overall Length <u>489</u> cm Maximum Width <u>184</u> cm Curb Weight <u>1408</u> kg Average Track <u>154</u> cm Front Overhang <u>119</u> cm Rear Overhang <u>113</u> cm Undeformed End Width <u>157</u> cm Engine Size: cyl./displ. <u>V8/5.4</u> L		WHEEL STEER ANGLES (For locked front wheels or displaced rear axles only) RF \oplus <u>0</u> <u>5</u> ° LF \oplus <u>1</u> <u>5</u> ° RR \pm _____ ° LR \pm _____ ° Within \pm 5 degrees
TYPE OF TRANSMISSION <input type="checkbox"/> Manual <input checked="" type="checkbox"/> Automatic		DRIVE WHEELS <input type="checkbox"/> FWD <input checked="" type="checkbox"/> RWD <input type="checkbox"/> 4WD

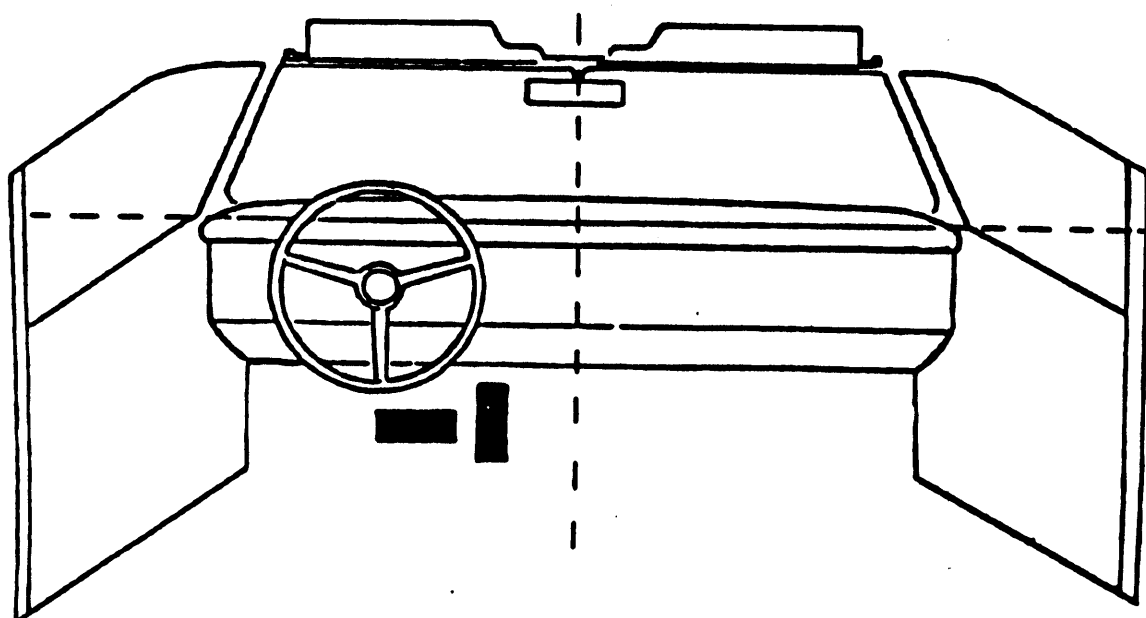
INTERIOR DESTROYED BY FIRE

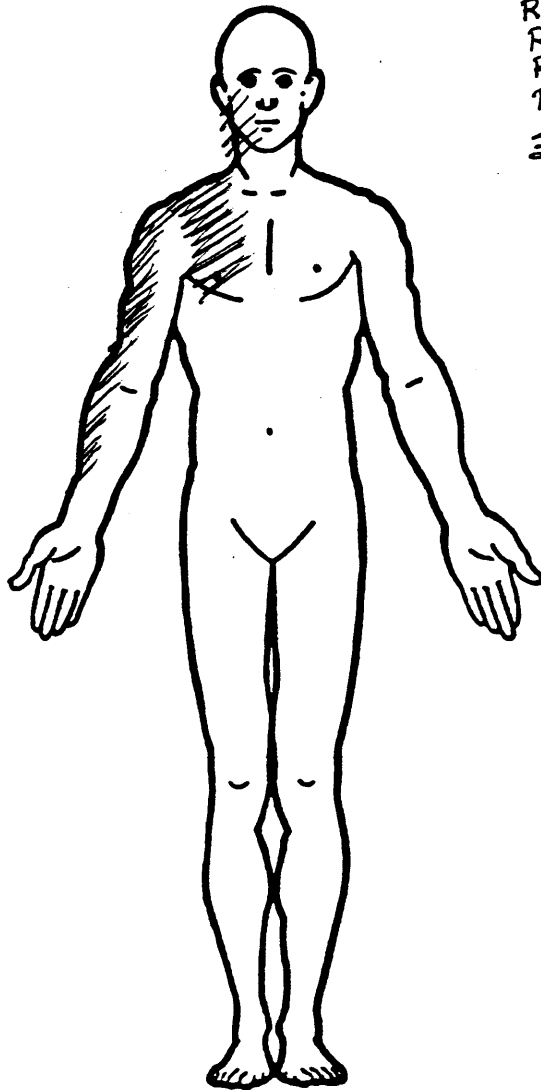
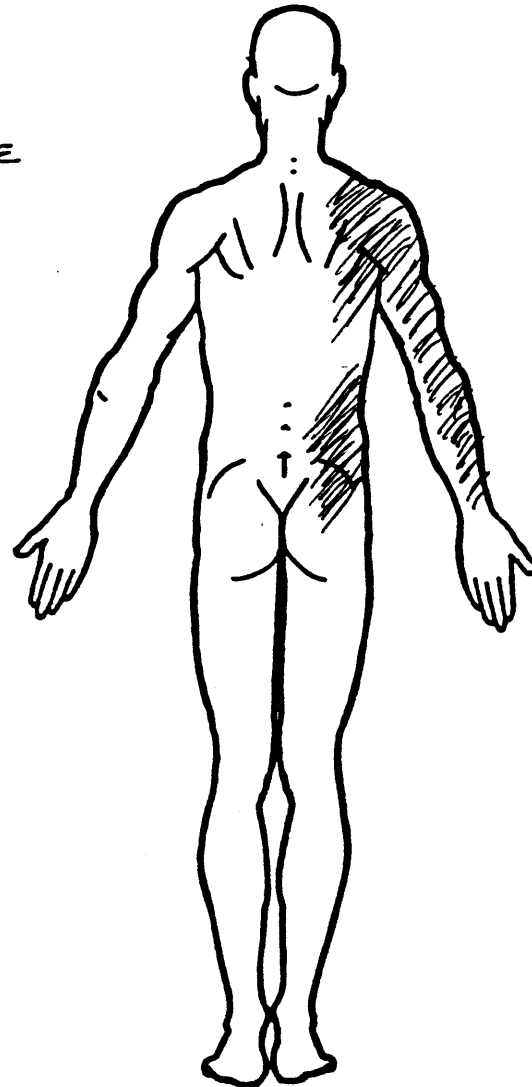
2° AND 3° BURNS

R. CHEST
R. SHOULDER
R. ARM
R. BUTTOCKS/FLANK
35% OF BODY SURFACE

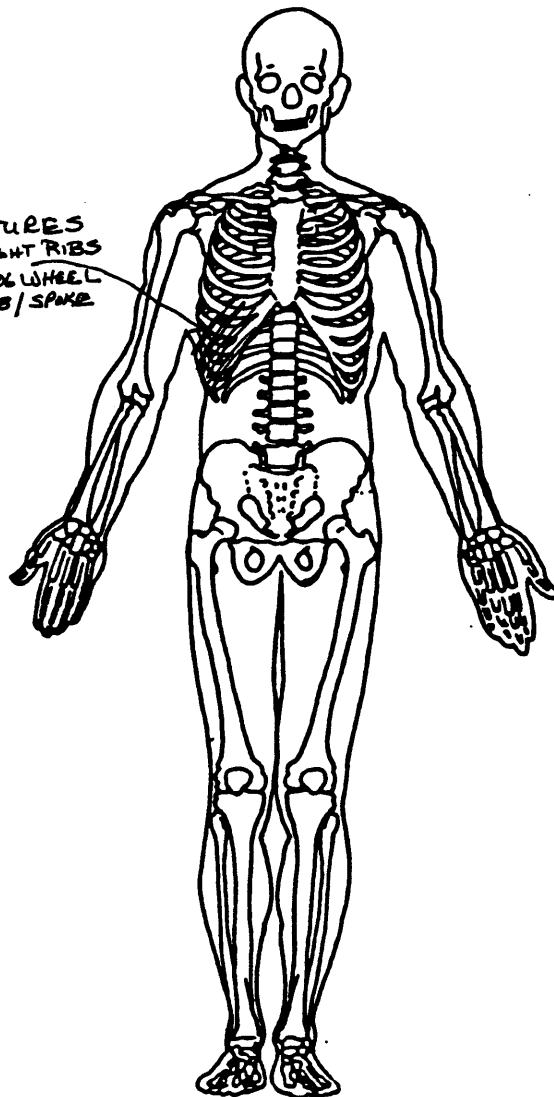
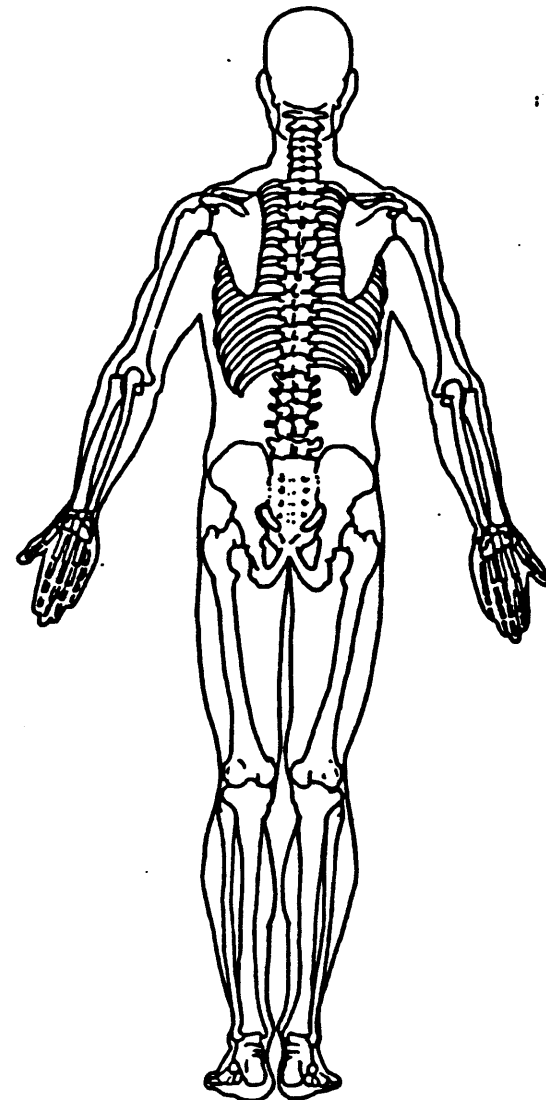
FRACTURES
2 RIGHT RIBS
STEERING WHEEL
RIM/HUB/SPoke
